# Chapter 7 - Infrastructure and Utilities

## INTRODUCTION

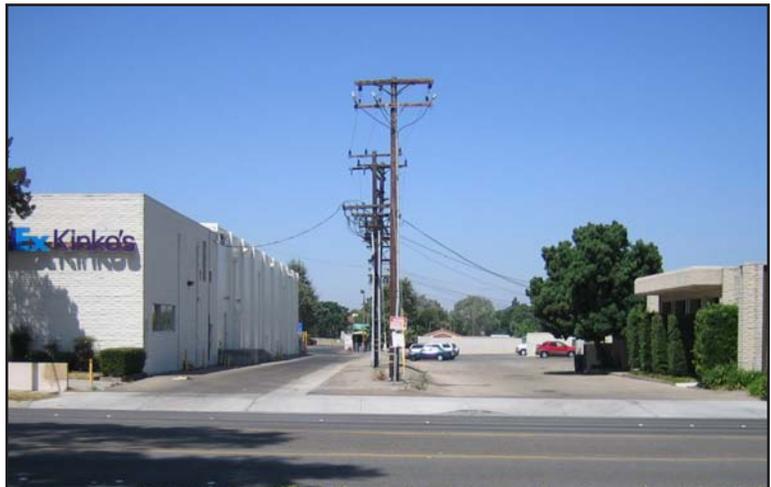
*Overhead Utilities Between Ponderosa North and Ponderosa Center off of Arneill Road.*

The majority of the Plan Area's services are provided for by overhead lines and services. As a condition of future development in the area, it is required that all overhead lines must be placed underground.

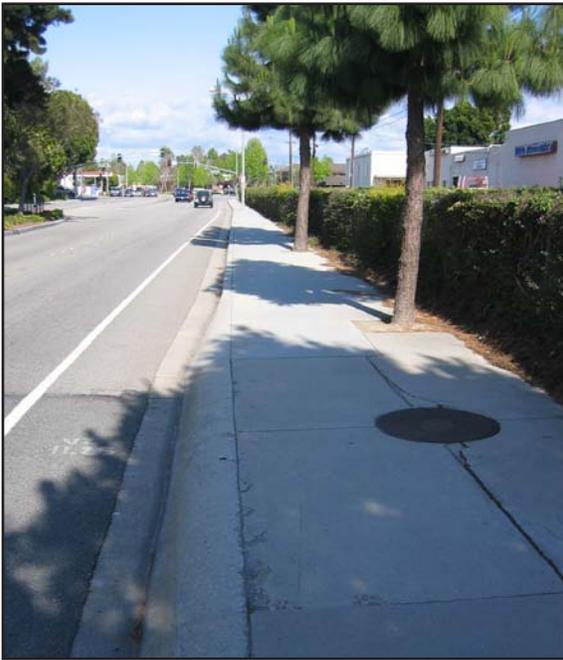
Portions of Ponderosa Drive consist of rolled curbs as opposed to standard curb and gutters. Where rolled curbs exist, the rolled curbs should be replaced with city standard curb and gutters.

*Example of Rolled Curb on Ponderosa Drive*

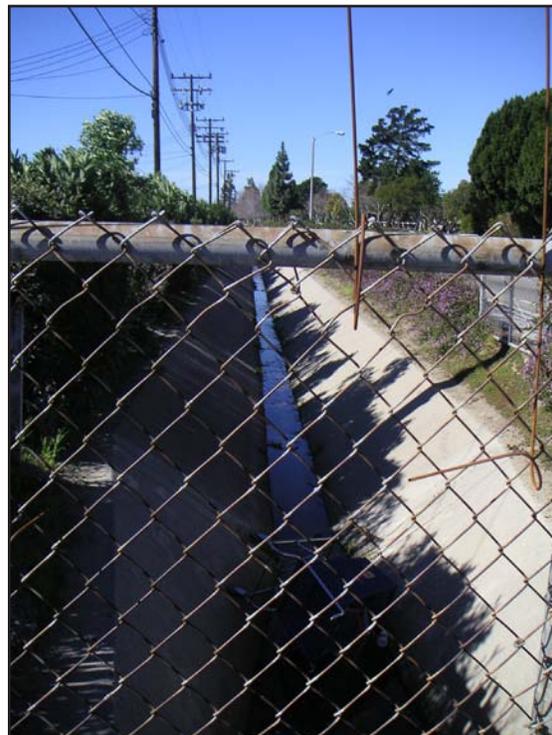
*Existing Storm Water Channel Along Ponderosa Drive*

The existing storm water channel on the north side of the project conveys storm water during storm events and appears to be sufficient for the current development. As noted earlier in this report, a portion of the storm water channel has been diverted to culverts and the storm water conveyed underground. There are no signs of system failure adjacent to the channel or underground culverts. Where the open channel exists along Ponderosa Drive, it should be covered with a permanent surface as discussed in the Cities CIP plan for the storm drain system.
